Natural Resources

U.S. Virgin Islands Comprehensive Land and Water Use Plan

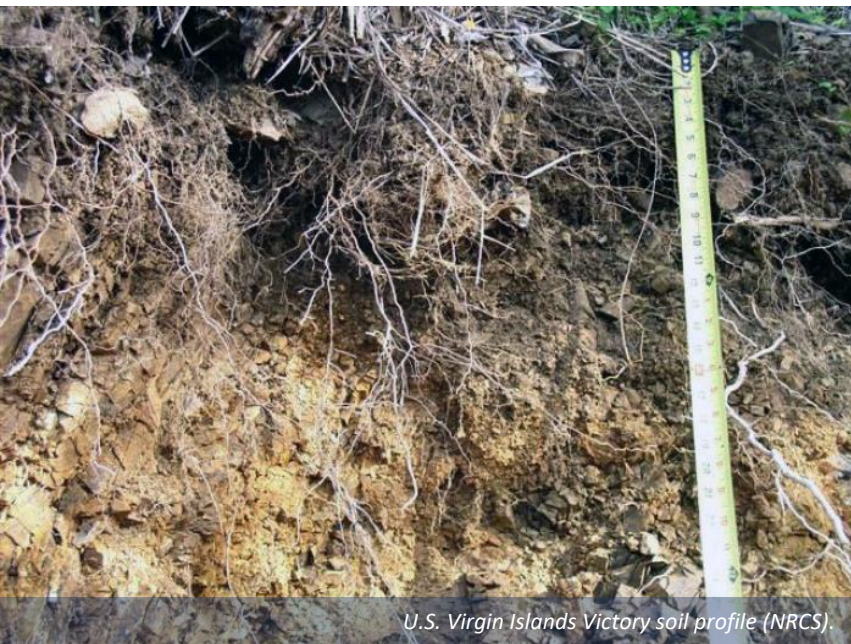
U.S. Virgin Islands Victory soil profile (NRCS).
